Failure investigation of a propped cantilever truss bridge

2.1 Lamgadi propped cantilever truss bridge

On January 24, 2022, the bridge connecting Gagangauda (Pokhara Metropolitan City ward 32) and Lamgadi (Pokhara Metropolitan City ward 33) over the Seti River in western Nepal collapsed before opening for the regular traffic. The bridge is a propped cantilever steel truss bridge with reinforced concrete deck. This is the first bridge of its type in Nepal. The bridge has a total span of 60 m with three trusses supporting a continuous concrete deck slab. The bridge was initially designed with 7.5 m carriageway width and 1.25 m sidewalk width on each side. The total width was later reduced to 7.2 m with 6 m wide carriageway 0.6 m sidewalk on each side. Each side of the deck has 1 m tall GI (Galvanized Iron) pipe railing. The deck slab is 200 mm at the edge and 275 mm at the center with 2.5% camber. The sidewalk is 300 mm above the carriageway. Joints in concrete deck are provided only between the abutments and the deck. The general arrangements of the structural system and the major components of the bridge are presented in Fig. 1. Similarly, Fig. 2 shows the structural system, bear

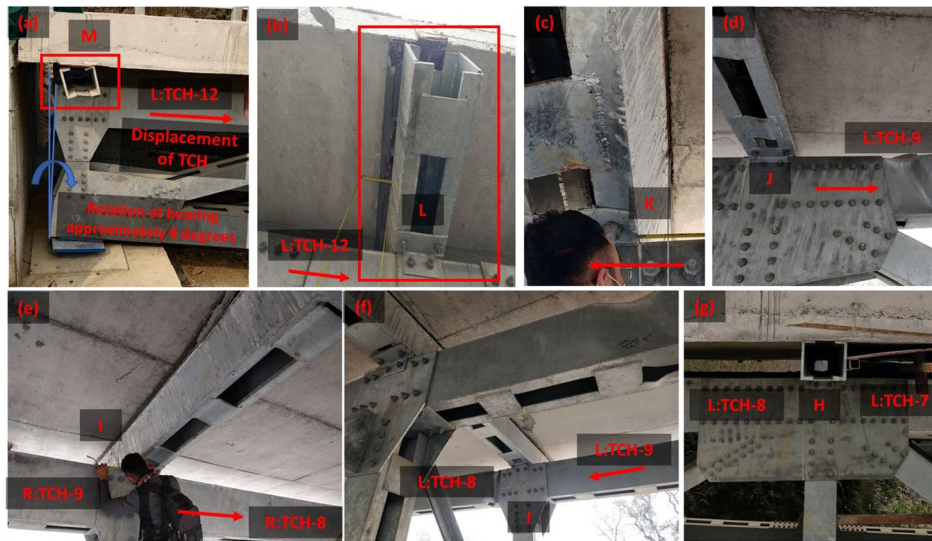
Rotation of the cross beams supporting the deck near the propped end was observed as shown in Fig. 6a. At joint M (see Fig. 2), which is the propped end, rotation of the cross beam resulted in the displacement of 68 mm between its top and bottom faces. Meanwhile, the beam did not slide relative to the deck. As shown in Fig. 5, the rotation of the bridge axis is the largest at joint M, which explains a significant rotation of the cross beam at this joint. At joint L, where the rotation of the bridge axis is the lowest, the cross beam slid by ~86 mm relative to the slab, while its rotation was not significant. Sliding between the deck slab and cross beams was observed only at two other cross beams: about 77 mm at joints J and K. Sliding between the top beams and the deck slab occurred only on the side of the bridge toward the propped end from the point where the deck deflection is maximum.

Fig. 6 Observed damage in top cross beam: **a** joint M, **b** joint L, **c** joint K, **d** joint J, **e** joint I at right truss, **f** joint I at left truss, and **g** joint H

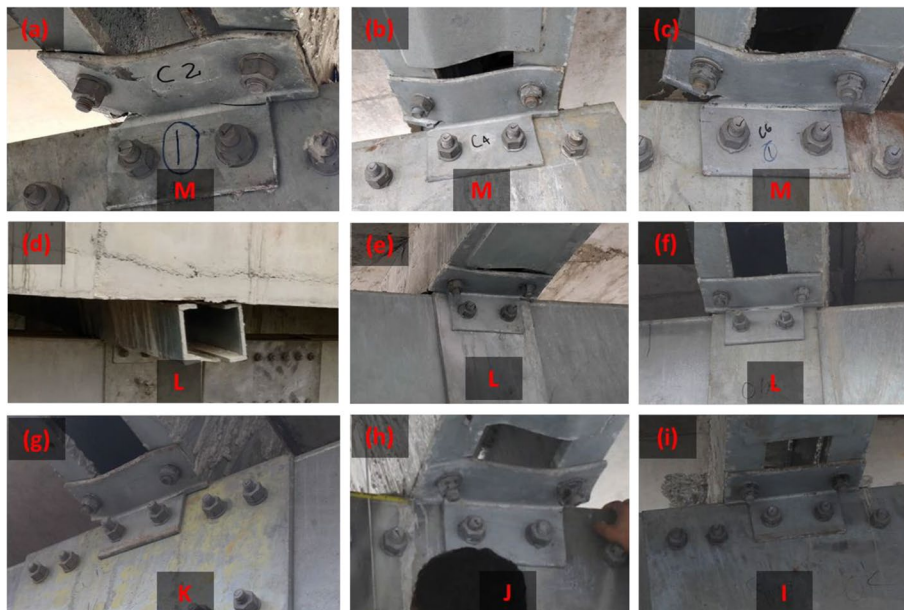
Cleat angles (see Fig. 3) were used to connect the top chord of the truss with top cross beams. Deflection of the bridge resulted in rotation of the top chord members, which caused the flange of the cleat angles connected to the top beams to bend. This resulted in tearing of the flange on one side. Then tearing of the cleat angles caused the top beams to rotate. Tearing was maximum at the propped end where the rotation of the deflected bridge is maximum. As shown in Fig. 7, damage was mostly concentrated at the propped end, which reduced gradually toward the center of the span. At joint L, the top beam slid

Fig. 7 Damage to cleat angles (uppercase alphabets in the figure represent the node IDs of the grid in which the joints are located)

relative to the deck meanwhile the cleat angle did not bend, this explains the lack of rotation of the top beam at this joint.

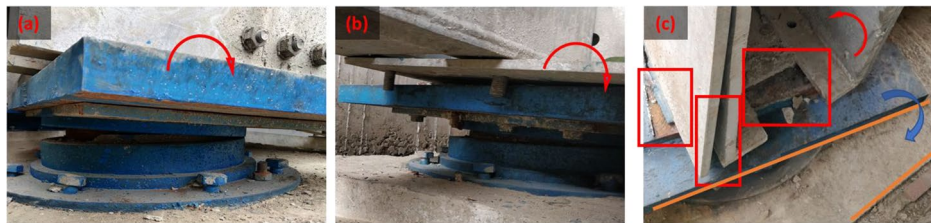
As shown in Fig. 11, all three bearings of B1 underwent significant rotation of about 8° due to deflection of truss. While no sliding was observed in any of the bearings B1, there was connection damage (weld damage) between the bottom chord of the truss and the wedge plate over the sole (top) plate of the bearing. Under the right truss there was about 11° of torsion of the bearing plate, but no noticeable torsion was observed at the other bearings.

Fig. 11 Damage to bearing B1: **a** bearing under the left truss with significant rotation, **b** bearing under the middle truss with significant rotation, **c** bearing under the right truss with significant rotation as well as torsion about vertical axis

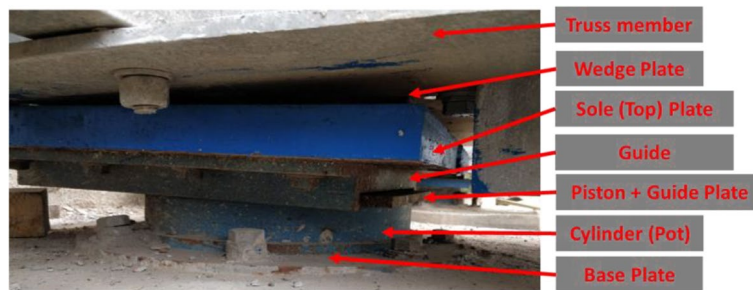
The arrangement of hinge roller type pot bearing at bearing A2 is shown in Fig. 12. The connection details are similar to that of the bearing B1; however, bearing A2 allows relative displacement of top bearing plate against the pot in the longitudinal direction. As shown in Fig. 13, the top plate, and the truss as well, moved toward the abutment with a sliding mechanism between the guide plate and the guide of the bearing. Also, not significant though, there was noticeable rotation at the pot bearing. The arrangement of steel hinge bearing at A1 is shown in Fig. 14, which did not observe any damage.

Fig. 12 Arrangement of bearings A2 depicting displacement of the top plate toward abutment against the pot

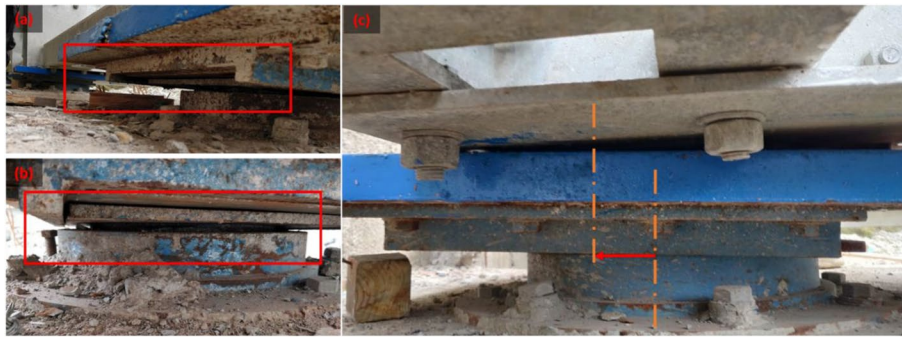
Fig. 13 Sliding at bearings A2: **a** outward movement of the top plate leaving the guide plate inside, **b** noticeable opening between pot and top plate in the abutment side of bearing due to significant rotation, **c** displacement of the top plate toward abutment against the pot

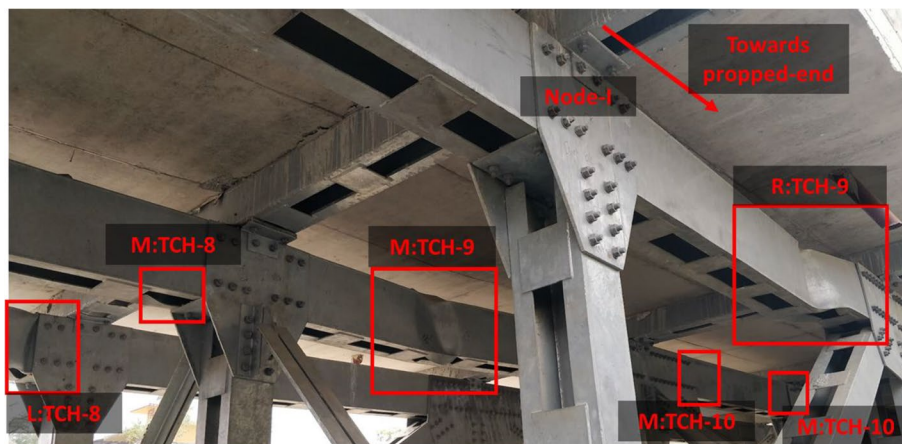
Three top chord members were found to be significantly damaged. The left top chord of panel-8 (L:TCH-8), middle top chord of panel-9 (M:TCH-9), and right top chord of panel-9 (R:TCH-9) were found to be buckled. The middle top chord of panel-8 (M:TCH-8) and middle top chord of panel-10 were also found to have slight local buckling as shown in Fig. 15.

Fig. 15 Observed damage mechanisms in the top chord members

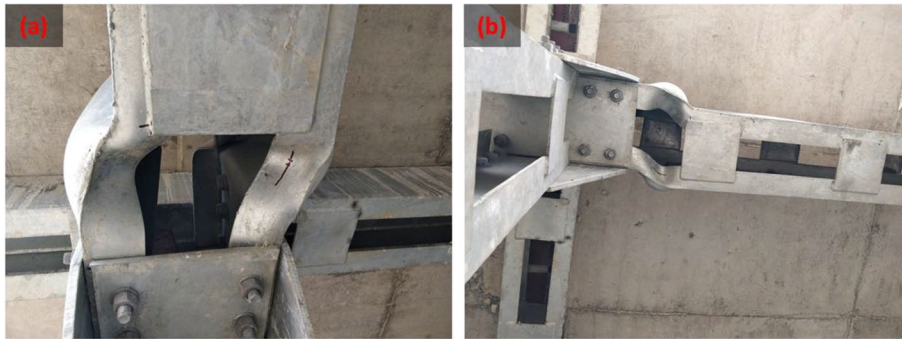
L:TCH-8 sustained localized damage near the connection as shown in Fig. 16. There was a local instability of the flange and web, most likely due to excessive compression. However, no tearing or damage to bolting or welding near the damage location was observed.

Fig. 16 Damaged top chord of the left truss: **a** close up view from the bottom **b** view from the bottom

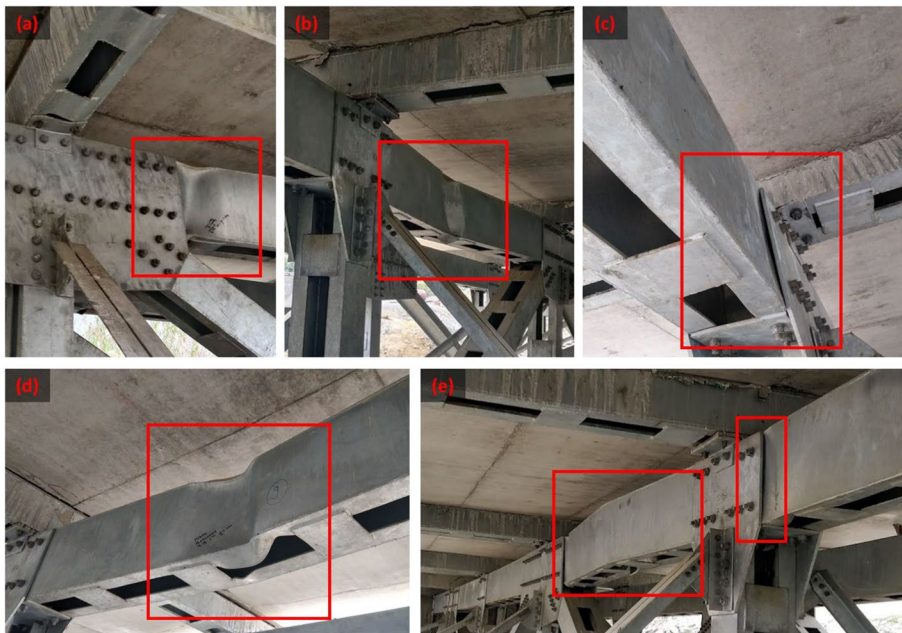
In the middle truss, M:TCH-9 was buckled excessively toward the downstream side by about 180 mm at a distance of 1550 mm from joint I. There was a local instability at M:TCH-8 near joint I, excessive buckling of M:TCH-9, and then again slight local buckling of M:TCH-10 near joints J and K as shown in Fig. 17.

Fig. 17 Observed damage in the top chord of the middle truss: **a** M:TCH-8 damage near joint I, **b** buckled M:TCH-9, **c** local buckling of M:TCH-10 near joint K, **d** interior face of buckled M:TCH-9, **e** exterior face of buckled M:TCH-9 and slight local buckling of M:TCH-10 near joint J

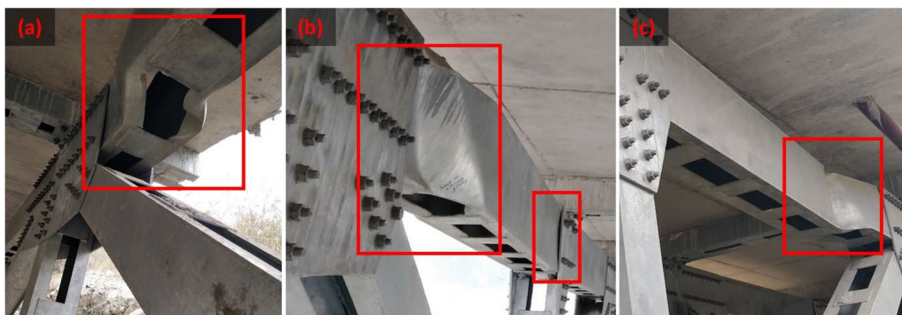
In the right truss (upstream side truss) also, a top chord member buckled excessively. R:TCH-9 was excessively buckled on the downstream side with some local buckling near joint I as well (Fig. 18).

Fig. 18 Damage to the top chord of right truss: **a** bottom view of R:TCH-9, **b** downstream side face of buckled R:TCH-9 and slight local buckling near joint I, **c** upstream side face of buckled R:TCH-9

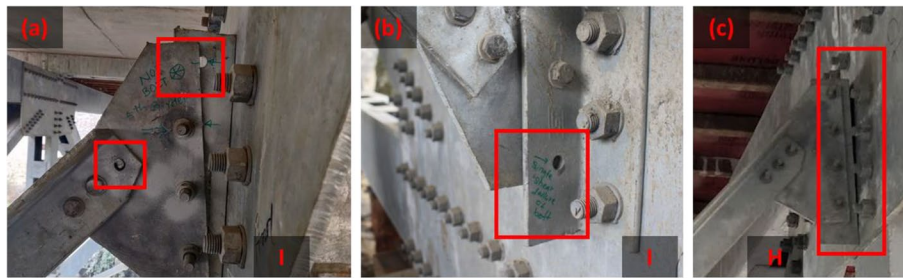
locations. Figure. 19 shows that there was damage to the bolted connection of the vertical connection at node I and some bending of the connecting angle at node H.

Fig. 19 Connection damage in vertical bracing: **a** at the top connection with middle truss at joint I of the vertical bracing between the middle and right trusses, **b** at the bottom connection with the right truss at joint I of the vertical bracing between middle and right trusses, **c** at the top connection with middle truss at joint H of the vertical bracing between the middle and the right trusses

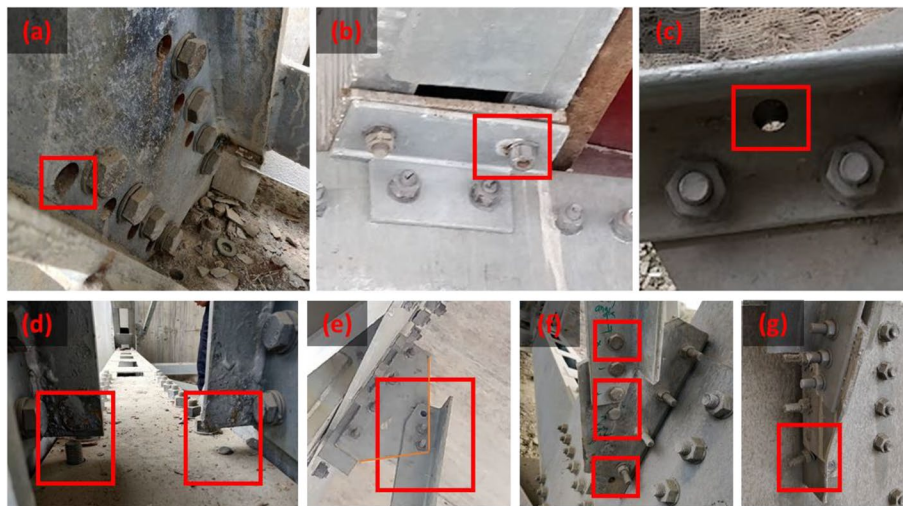
A few misfits of members and alignment issues of holes in bolted connections were identified during field investigation. Figure. 20 shows some of the connection issues that include imperfect connection of several vertical braces. Less than three bolts were effective in many vertical brace connections although more bolts were provided.

Fig. 20 Construction defects in various parts of the structure: **a** holes drilled twice due to error in the diagonal chord, **b** misalignment of hole in cleat angle, **c** misaligned hole in bottom horizontal bracing, **d** vertical chord prohibiting bolted connection of the top plate of the bottom chord, **e** connection of vertical bracing without sufficient edge distance on gusset plate, **f** less active bolts with two idle bolts and a misaligned hole, **g** inactive bolt on gusset plate

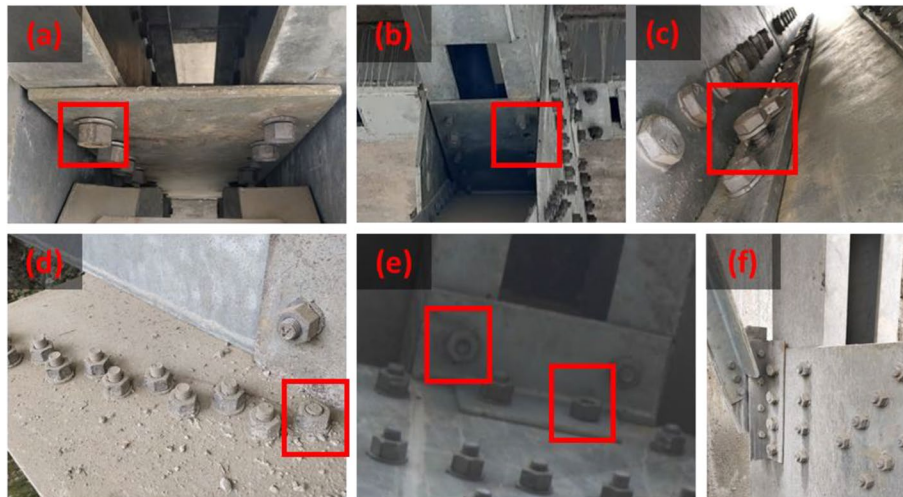
Although it was claimed that all the elements of the bridge were fastened and the builder was ready for load test, some of the bolts were found not well tightened or even missing. A site personnel said that some of the bolts were loosened or removed after the collapse for lifting the bridge; however, we were not able to verify the claim independently. Figure. 21 shows some connections with a few or more bolts in loosened state, which were most likely untouched even after the collapse of the bridge considering the state and location of bolts. Most of the loose bolts of the bottom plate are not directly visible from ground due to obstruction by the diagonal members. Also, a vertical diagonal at joint A was found to be connected slightly eccentrically at the left truss bottom part against the general practice of concentric connection on all other parts and considering the general pattern of construction at site. It was due to the placement of connecting angle in improper orientation, i.e., the outstanding flange of the connection was expected toward the center of the joint, but it was installed toward the abutment.

Fig. 21 Connection issues in some parts of the structure: **a** incompletely tightened bolts at the bottom plate of top chord, **b** missing bolts at the bottom plate of the top chord, **c** untightened bolts at the bottom plate of the top chord, **d** untightened bolts at the bottom bracing connection, **e** improperly tightened bolts at the connection of a cleat angle, **f** eccentrically connected vertical bracing

However, this variation is not linked to the cause of the present failure but indicates undesirable workmanship quality of work.

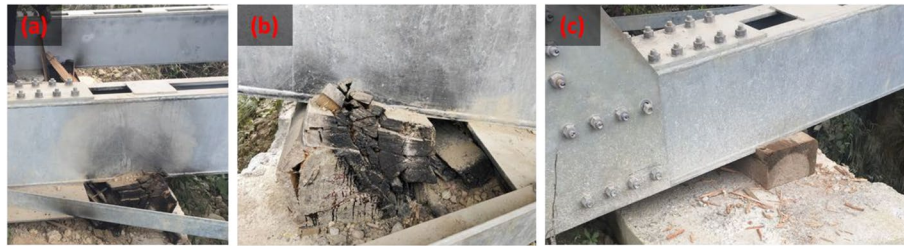
Stage 2 During removal of the remaining two temporary supports at X, there was some settlement during burning of the timber block as shown in Fig. 36.

About 10 mm settlement was estimated under the left and middle truss supports at X due to shrinkage of the timber support block. During this loosening process, the horizontal reaction provided by friction was also lost. Hence, the roller at the fixed end and side end started to roll slowly toward the abutment. During this process, the settlement increased significantly, and high compression force was transferred to concrete slab, especially near the propped side. Hence, the connection (cleat angles) started to yield and tear causing tearing sound as heard by the workers. Then, the left top chord underwent local buckling suddenly causing a loud noise.

Fig. 36 Temporary supports at X: **a** under the middle and left trusses that were crushed after burning, **b** close up view of temporary support under middle truss, **c** restored temporary support under right truss
