Failure investigation of a propped cantilever truss bridge

2.1 Lamgadi propped cantilever truss bridge

On January 24, 2022, the bridge connecting Gagangauda (Pokhara Metropolitan City ward 32) and Lamgadi (Pokhara Metropolitan City ward 33) over the Seti River in western Nepal collapsed before opening for the regular traffic. The bridge is a propped cantilever steel truss bridge with reinforced concrete deck. This is the first bridge of its type in Nepal. The bridge has a total span of 60 m with three trusses supporting a continuous concrete deck slab. The bridge was initially designed with 7.5 m carriageway width and 1.25 m sidewalk width on each side. The total width was later reduced to 7.2 m with 6 m wide carriageway 0.6 m sidewalk on each side. Each side of the deck has 1 m tall GI (Galvanized Iron) pipe railing. The deck slab is 200 mm at the edge and 275 mm at the center with 2.5% camber. The sidewalk is 300 mm above the carriageway. Joints in concrete deck are provided only between the abutments and the deck. The general arrangements of the structural system and the major components of the bridge are presented in Fig. 1. Similarly, Fig. 2 shows the structural system, bear

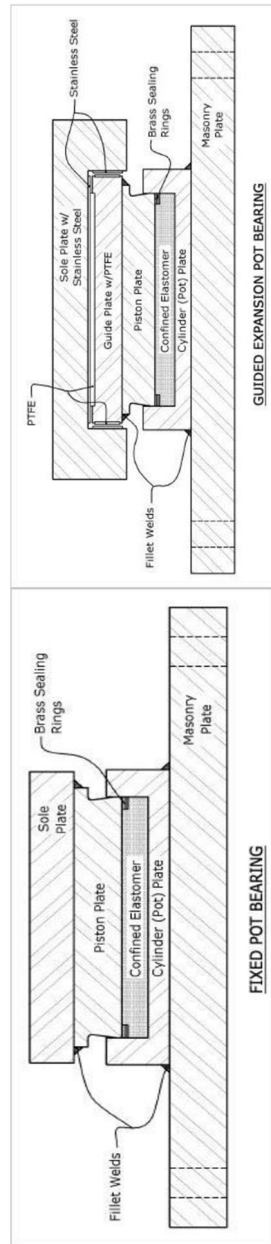
Fig. 8 Schematic diagrams of hinge-type (left) and roller-type (right) bearings

Some of the bearings were found to be damaged. Bearing A1 is steel hinge bearing at the top of the fixed end, bearing A2 is hinge roller type pot bearing at the bottom of the fixed end side, and bearing B1 is hinge type pot bearing at the propped end. A schematic diagram of the pot bearing is presented Fig. 8. Figure. 9 shows the arrangement of hinge type pot bearing (bearing B1). An additional wedge plate was used to accommodate the designed slope of the bottom chord of the truss. The wedge plate was welded over the sole plate of the bearing. The bottom plate connected to the bottom face of the bottom chord of the truss was also welded. The truss bottom plate was connected to the truss element with bolted connection outside the bearing but welded over the bearing as bolted connection was not possible in this part as shown in Fig. 10. Significant rotation of bearing was observed at bearing B1 with some torsion on one of the bearings while some sliding was observed at bearing A2.

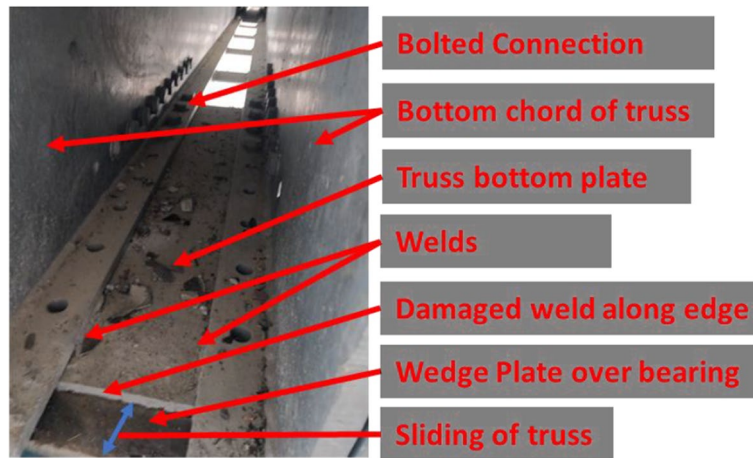
Fig. 10 Connection of truss and bearing at bearing B1

As shown in Fig. 11, all three bearings of B1 underwent significant rotation of about 8° due to deflection of truss. While no sliding was observed in any of the bearings B1, there was connection damage (weld damage) between the bottom chord of the truss and the wedge plate over the sole (top) plate of the bearing. Under the right truss there was about 11° of torsion of the bearing plate, but no noticeable torsion was observed at the other bearings.

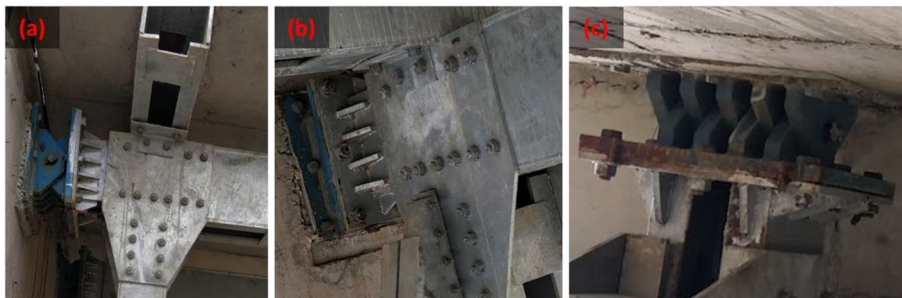
Fig. 14 Steel hinge bearing A1: **a** side view, **b** oblique view, **c** bottom view

The arrangement of hinge roller type pot bearing at bearing A2 is shown in Fig. 12. The connection details are similar to that of the bearing B1; however, bearing A2 allows relative displacement of top bearing plate against the pot in the longitudinal direction. As shown in Fig. 13, the top plate, and the truss as well, moved toward the abutment with a sliding mechanism between the guide plate and the guide of the bearing. Also, not significant though, there was noticeable rotation at the pot bearing. The arrangement of steel hinge bearing at A1 is shown in Fig. 14, which did not observe any damage.

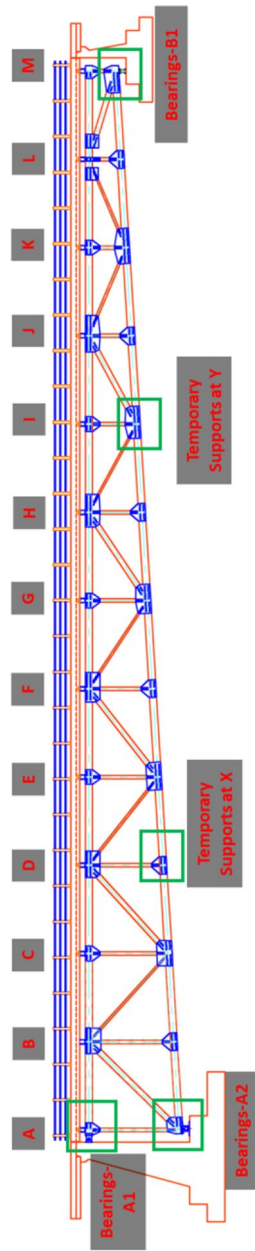
Fig. 22 Arrangement of temporary supports at the end of construction phase

Damage to the bridge initiated during the removal of temporary supports after the completion of fastening work of the steel truss as claimed by the workers involved in casting and hardening of the deck. Three temporary supports at Y (see Fig. 22) were removed without any noticeable damage or deformation. However, during removal of three temporary supports at X by hammering the timber blocks, only a support under the right truss came out and to loosen others they were fired and hammered. During hammering, there was sudden damage after which temporary supports were restored.

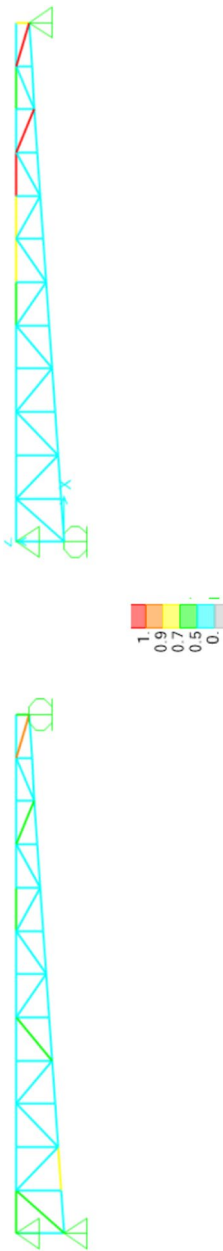
Similarly, all the estimated member forces were found to be well below their capacities for case A, but a few members were found to be overstressed for case B (Fig. 27). DCH-10 and DCH-12 were especially overstressed with a compression ratio of 1.6 while TCH-9 has compression ratio of almost unity when a design check was done as per the IS 800:2007 guidelines (Bureau of Indian Standard 2007), considering partial safety factors for load and material as unity. For this state, a high compression load needs to be transferred to the deck slab as shown in Fig. 28. It clearly shows that case B requires significantly high compression to be transferred to the deck slab and the slab needs to

Fig. 27 P-M-M ratio contours for case A (left) and case B (right)
